Ceramic ball valve controls erosive slurry without obvious wear

New Solutions to Plant Problems

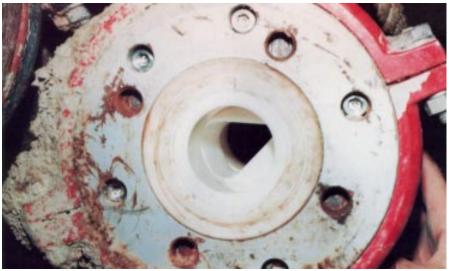
Ceramic ball and body of rotary control valve are still in like-new condition after months of service with extremely erosive slurry

control valve specially designed for extremely corrosive, abrasive and erosive service was installed in the slurry line. All critical wetted parts of the valve are cast alumina ceramic (Al₂O₂), a material next to diamond in hardness and almost impervious to wear, and resistant to strong acids and alkalis. Shaft materials include ceramic, stainless steel, Hastelloy® alloy, alloy 20 and titanium. The ceramic ball, body and end sections, which include tapped holes for pipe flanges, are completely encased in a steel housing for maximum strength and protection. The valve was awarded Top Honors for control valves in the 1984 CHEMICAL PROCESSING Vaaler competition.

Results: The 2" ceramic rotary control valve and pneumatic actuator have been trouble-free since they were installed in September, 1983. The award-winning valve has been inspected every six weeks and is still without visible signs of wear by the erosive slurry. The cost of the valve was repaid within the first year, and the indefinite projected service life will provide additional savings.
